## **2. PORTSMOUTH DUE DILIGENCE REVIEW**

The Portsmouth Due Diligence Review covers the Facility Specific Descriptions and Documentation completed for the final 14 facilities designated for return to DOE.

### **2.1 X-105 ELECTRONIC MAINTENANCE BUILDING**

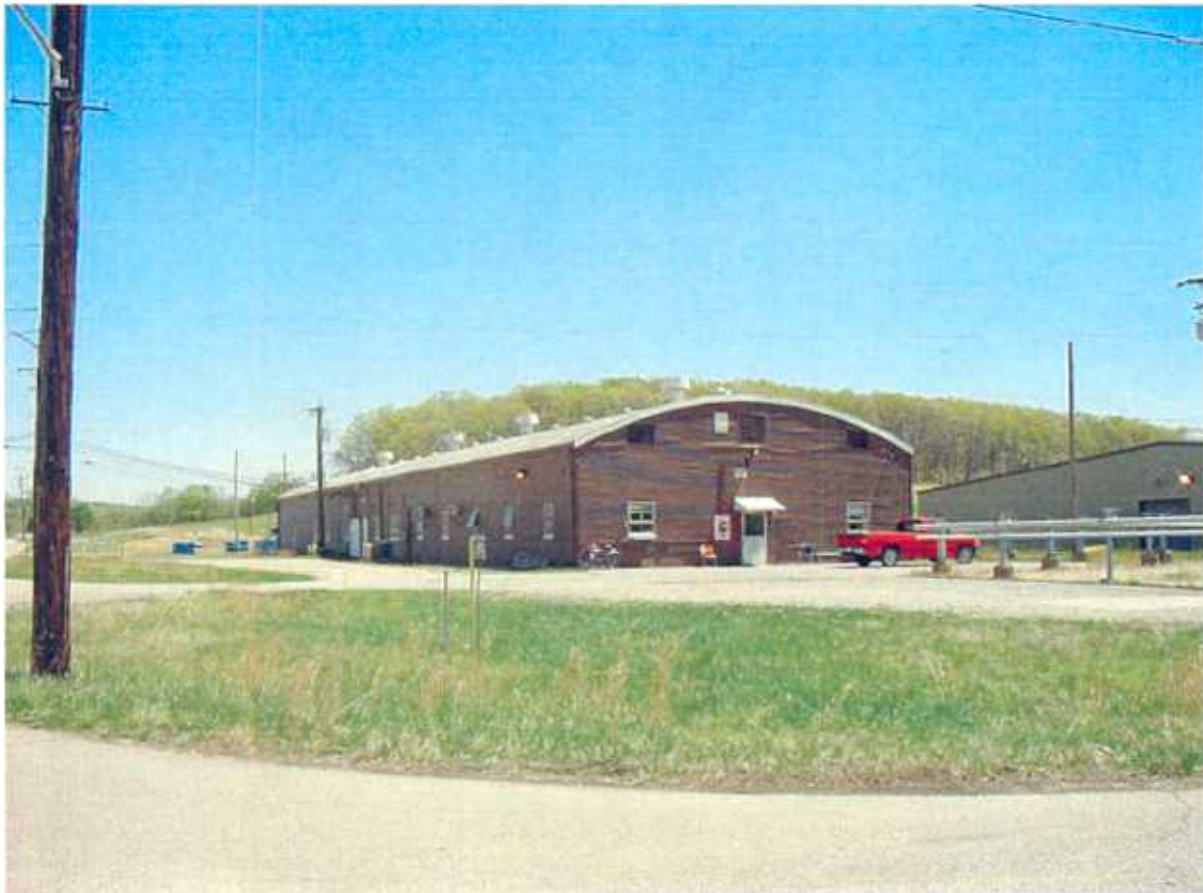
**Fig. 2.1 X-105 Electronic Maintenance Building exterior looking east.**

The X-105 does not appear to be subject to flooding or significant water leaks; however, there are signs of water damage to the ceiling in many areas. Wastewater from the restroom, drinking fountain, and the restroom drains is discharged to the sanitary sewage system.

There is an active condensate leak from the steam heater in Room #2. Numerous signs of steam leaks were noted throughout the building on valved off steam heaters. Additionally, there are numerous steam regulators inoperable throughout the building. The main steam valve on the outside of the building on the southeast side is leaking. The two central air conditioning units needed repeated maintenance and repair last summer. Given the age of the facility, the two central air conditioning units and five window type air conditioners very likely contain chlorofluorocarbons (CFCs). There are holes in the sheet metal siding on the west and south sides, the bottom of siding is rusted and deteriorated in some areas around building, and the siding is dented on the north side. There are two broken windows, one on the north side

and one on the south side. The entrance walk-in door needs painting. During interviews with the building custodian it was learned that the original drywall was tested and was found to contain asbestos. This original drywall has some holes and cracks. The concrete floor is cracked, but not separated and the original floor tile contains asbestos, but is covered with new floor tile or carpet in some areas. However, there are a few areas where the original floor tile is still visible. Paint is flaking off the air duct in the electrical storage area. The hot water dispenser on the drinking fountain is leaking. The showers are not being used and have been declared inoperable. Approximately 10% of the lighting fixtures need relamping, most of the receptacles and light switches do not have power source labels, and the kitchen outlets do not indicate ground fault interruption circuits. The Electrical/Utility room looked well marked and maintained. However, it does need some housekeeping attention.

- A/C repairs (main unit & window units);
- Replace water fountain;
- Repair broken window;
- Unclog water fountain drain;
- Repair restroom plumbing;
- Remove asbestos from water line;
- Clean up asbestos laying on ground outside on north side of building;
- Custodial; and
- Relamping.

It is recommended that this facility not be occupied and be placed on the list for early D&D. Actions will be required to isolate the steam supply to the building and drain all lines of condensate to prevent winter freezing. Additionally, it is recommended that the existing fire protection system be isolated, drained, and air-dried to preclude winter freeze damage. The X-105 should then be electrically isolated, locked and abandoned until D&D efforts can be initiated.

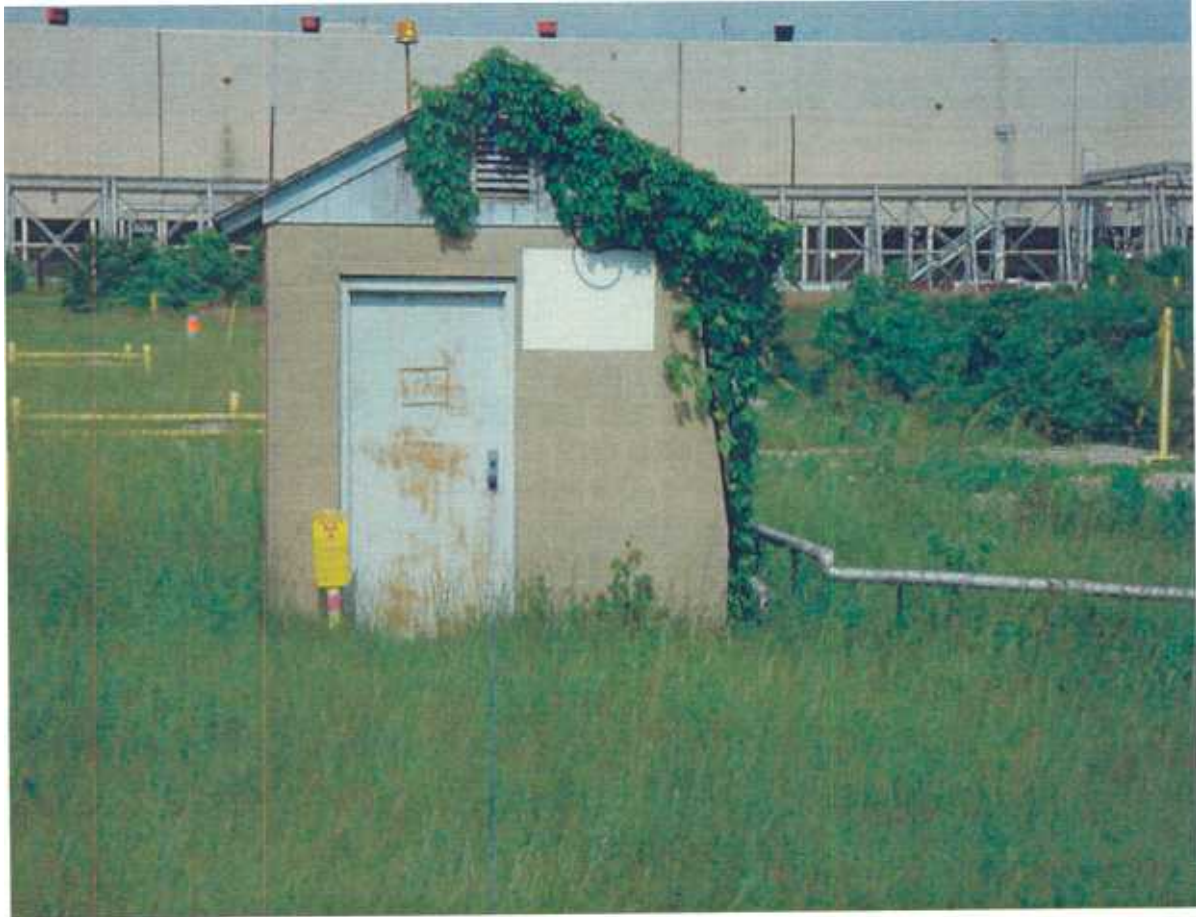
**Fig. 2.3 X-230J-1 Environmental Monitoring Station looking west.**

The facility was out of service prior to the USEC lease. The overhead electrical service has been cut and is coiled up at the side of the building. This abandoned service drop should be removed. There was a small amount of miscellaneous sanitary trash (empty plastic bottles, boundary tape, and a radiological stanchion). The shingled roof has deteriorated, the door needs paint, and the drywall ceiling was never finished.

The X-230J-1 building is a posted Fixed Contamination Area, the power has been disconnected, and the door is locked. It is recommended that the X-230J-1 be placed into DOE's Deferred Maintenance Program and on the short range D&D list.

De-leasing of this facility from USEC to DOE poses no additional or unknown risks or liabilities to DOE. The facility is essentially abandoned and it is recommended that the building remain locked, abandoned, and be considered for early entry into the D&D program.

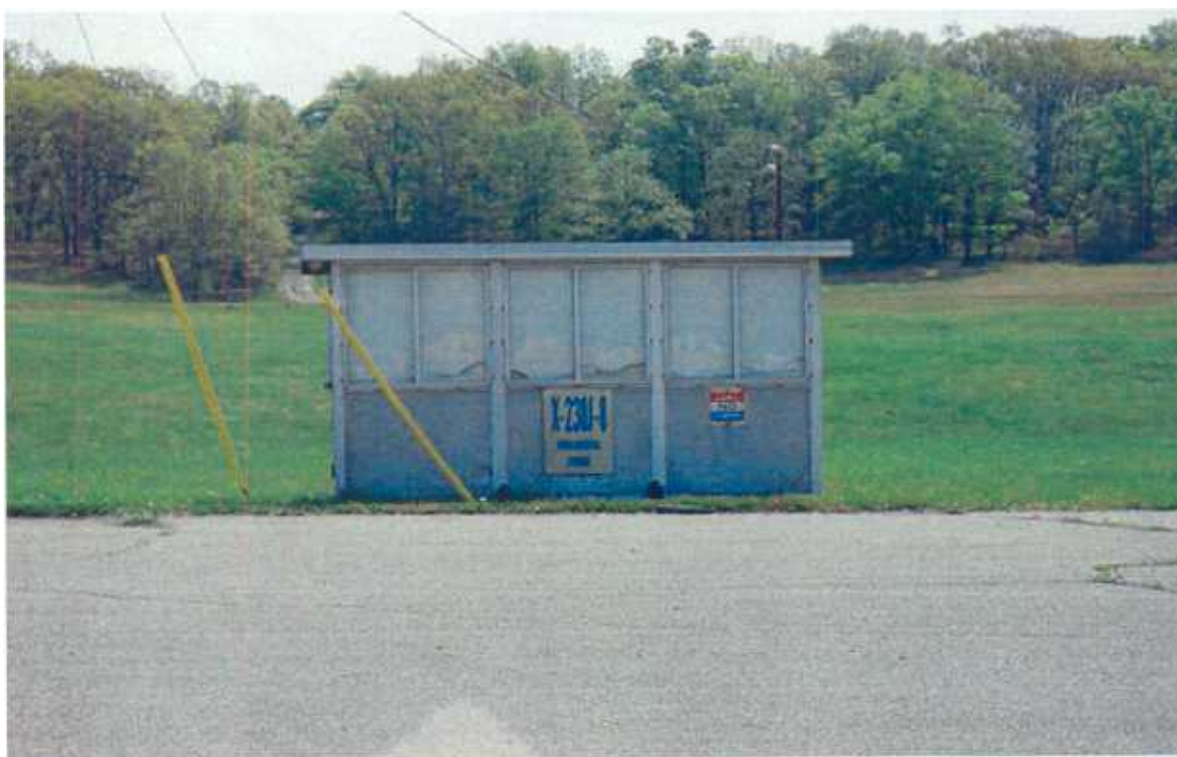
**Fig. 2.5 X-230J-8 Environmental Storage Building looking east.**

The building does not appear to be subject to flooding. However, the walls have signs of water damage. The X-230J-8 has no floor drains and no water supply to the temporary structure.

Although the facility is bolted down, the X-230J-8 is a temporary portable structure that may be subject to damage by high winds. The design basis information was not provided, and integrity of the structure was not verified during this walkdown.

It is recommended that a one time cost be incurred to disconnect the power and move this portable office building to a DOE warehouse-type facility and "hold for future use" or surplus and sell this unit.

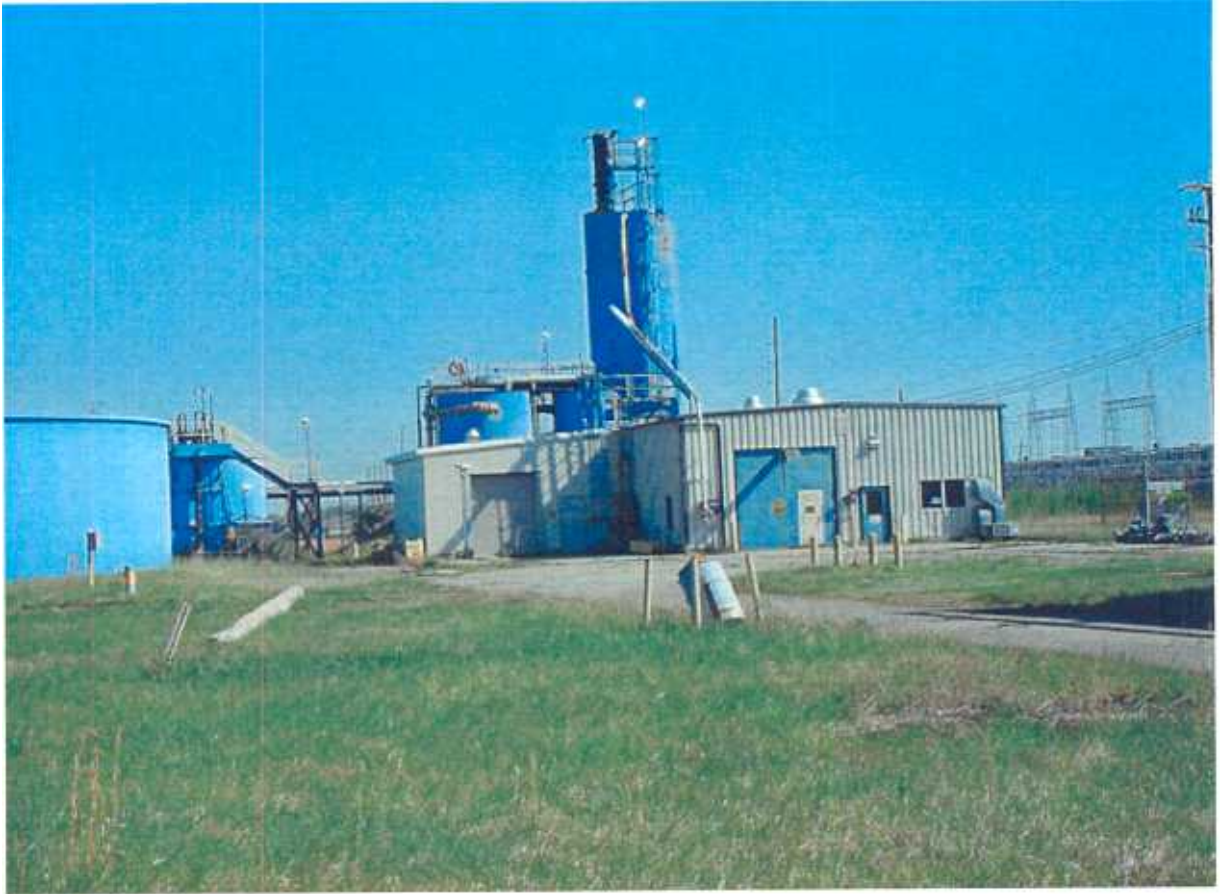
**Fig. 2.9 X-616 Liquid Effluent Control Facility looking north.**

Friable asbestos containing material has been reported in this facility (Report for Environmental Audit Supporting Transition of the Gaseous Diffusion Plants to USEC, 6/93). Some damaged insulation that could possibly contain asbestos was noted around pipes leading to the large tanks outside of the Control Building.

The Control Room lab sink located near the south end of the Control Building drains into a sewer pipe. The sewer pipe is broken about 6" above the floor. A wash basin located near the north end of the Control Room in the Control Building drains into a floor drain located by Polymer Tank #2 near the east end of the Equipment Room. Drinking water and waste from the sink flow to a sump in the Control Building, then subsequently discharged to the Scioto River through Outfall 004 (Report for Environmental Audit Supporting Transition of the Gaseous Diffusion Plants to USEC, 6/93).

A roof panel in the lime feed area is damaged and hanging down. The downspouts on the north and south sides need to be repaired and the entrance doors need to be painted. There is hardened slaked lime on the equipment, floor, and walls of the lime feed area. The bottom trim on interior wall panels is rusted and corroded and the floor tile in the control room needs to be replaced. Approximately 20% of the lights need to be relamped. The liquid level control flex conduit fitting on the lime slurry tank is loose. The "T" conduit on the east side needs to be plugged and the cannon connector needs to be reinsulated. The conduit, control panels and fittings in the process area are corroded. There is excessive vegetation growth around the pad-mounted transformer which could cause tracking should the ivy get into the energized terminals of the transformer. The weeds need to be controlled, and the facility de-energized from the 13.8 kV overhead line.

USEC has committed to isolate the facility from the blowdown path to Outfall 004 by valving off and installing blank plates on two underground water pipes that formed a prior sampling loop through the facility. It is recommended that the facility be deactivated, power and utilities turned off, and the doors

USEC has a project in place to isolate and blank-off the blowdown outfall line that is scheduled for completion by October 31, 2001. Until that time, the recommendation is to agree to a mutual lock and tag of the sampling loop isolation valves until the modification is completed.

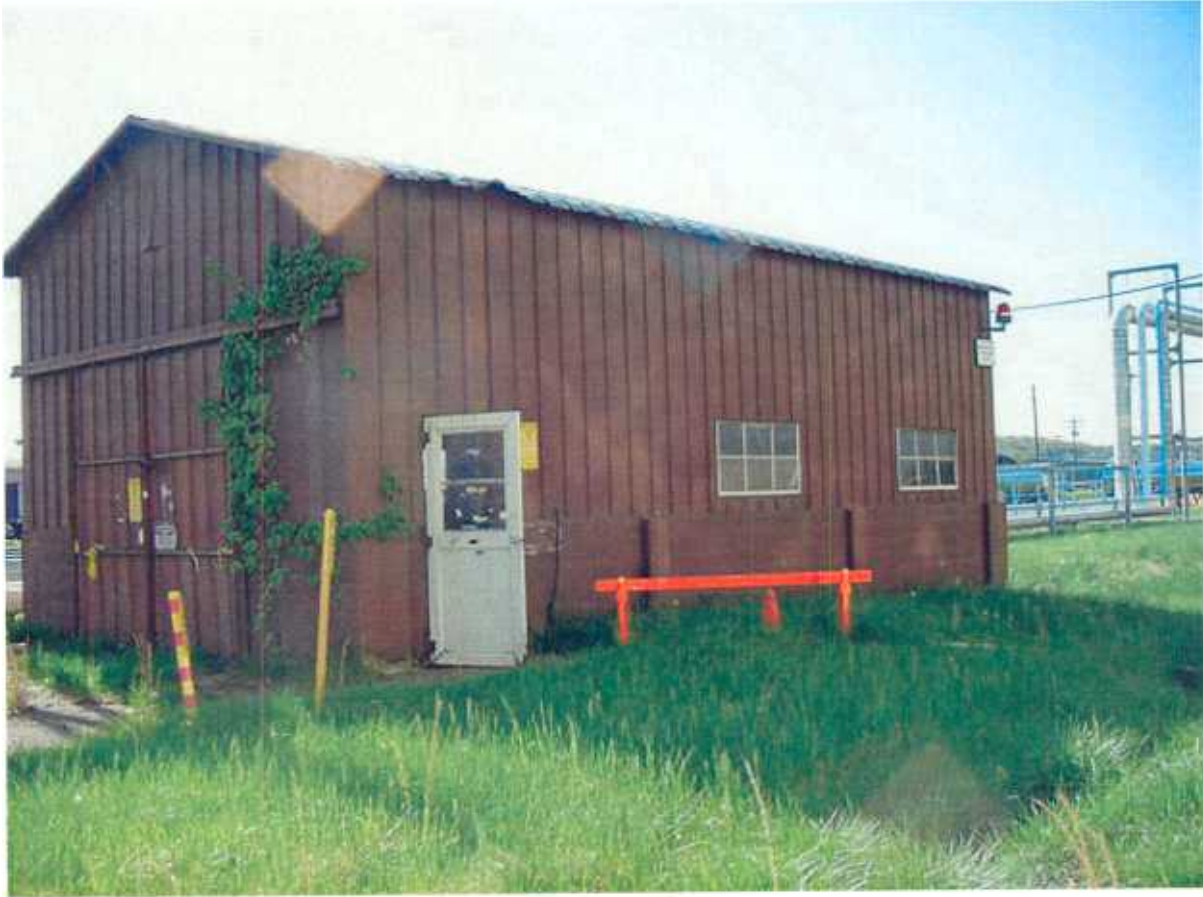
**Fig. 2.11 X-701D Water Deionization Building looking east.**

Steam lines and steam heaters are inactive and were isolated due to a leak in the line just south of the facility. The steam heaters appear to be in fair condition. Sanitary water piping is active at least to the emergency shower. In other areas it appears to have either been capped or valved off. There is standing water on the facility floor, but the source could not be determined. A sanitary sewer line is connected to a washbasin, but no sanitary water is currently being provided. Steam, sanitary sewer, and sanitary water lines are underground until they enter the facility. At that point, all are aboveground. The emergency shower is inspected on a regular basis.

Poison ivy was found growing up the north side of this facility. Two vacuum cleaners are stored in the northeast corner of the facility inside a radiologically "Contaminated Area". There are signs of the roof leaking and the metal structure is rusting throughout. The doors are rusted and deteriorated, windows on the east and west side are broken, the roof is damaged on the west side and the interior paint has deteriorated. There is extensive cracking of the floor. Electrical equipment and services are unlabeled. Electrical conduits, fittings, switches and outlet boxes are corroded. Covers are missing on outlet boxes in several locations with plastic tied over switch plates to shield them from rain.

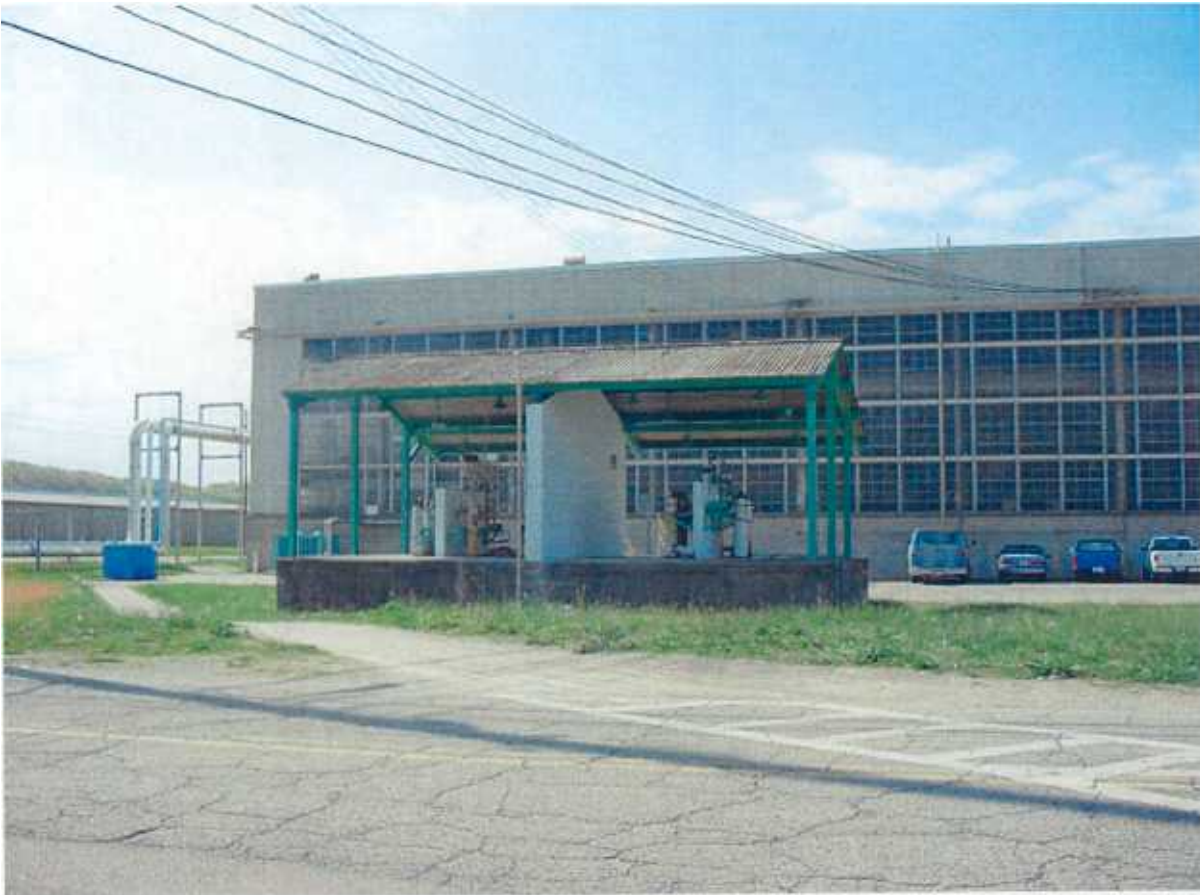
**Fig. 2.13 X-720A Maintenance and Stores Gas Manifold Shed looking south.**
